Subject: Approve an Extension of the Project-based Master HAP Contract with Ashby Lofts for a period of 5 years (Aug. 2022 - July 2027)

Ashby Lofts
2909 and 2919 9th Street
Berkeley, California 94710

Key Findings

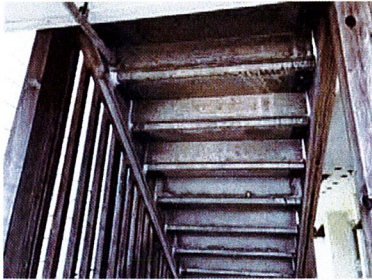
Stairs in Poor condition.

Concrete, Exterior
Ashby Lofts Throughout building

Exterior stairs show deterioration of wooden members and corrosion of metal elements. - AssetCALC ID: 3270061

Uniformat Code: B1081
Recommendation: **Replace in 2021**

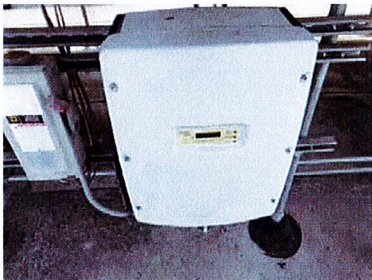
Solar Power in Poor condition.

Inverter
Ashby Lofts Roof

System is reported to be unreliable. - AssetCALC ID: 3270074

Uniformat Code: D5013
Recommendation: **Replace in 2021**

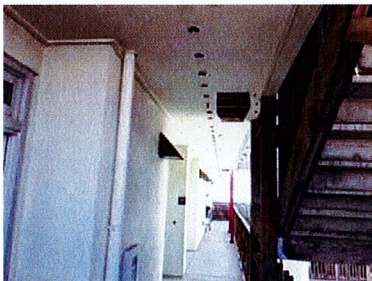
Wood Stair Damage in Poor condition.

Concealed
Ashby Lofts Exterior stairs

Uniformat Code: B1081
Recommendation: **Repair in 2021**

Repair damage to exterior structure surround staircases based on current evidence of moisture intrusion from staircases to surrounding building structure. - AssetCALC ID: 3295463

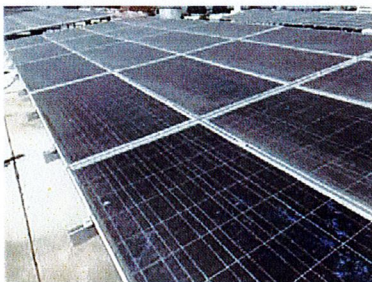
Solar Power in Poor condition.

Photovoltaic (PV) Panel, 24 SF
Ashby Lofts Roof

Uniformat Code: D5013
Recommendation: **Replace in 2022**

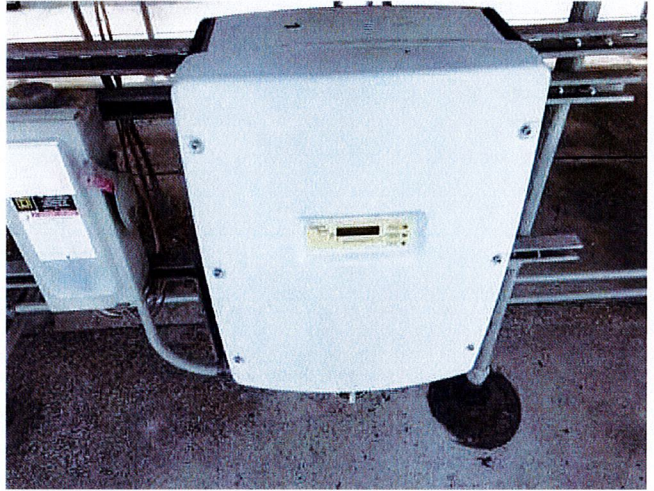
46 - SOLAR POWER, INVERTER

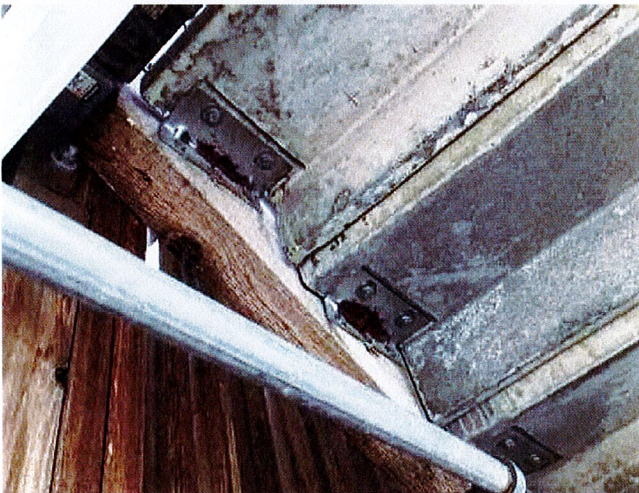
47 - CORROSION ON STAIRCASE

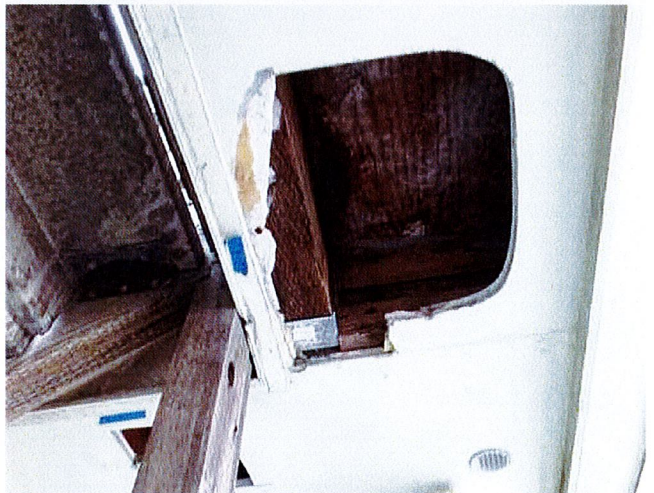
The exterior stairs showed signs of water intrusion and wood structural member deterioration in multiple locations for the exterior stairs and the surrounding building structure.

48 - WATER DAMAGED WOOD FROM WATER INTRUSION
