Subject: Approve an Extension of the Project-based Master HAP Contract with Ashby Lofts for a period of 5 years (Aug. 2022 - July 2027)

Ashby Lofts
2909 and 2919 9th Street
Berkeley, California 94710

Key Findings

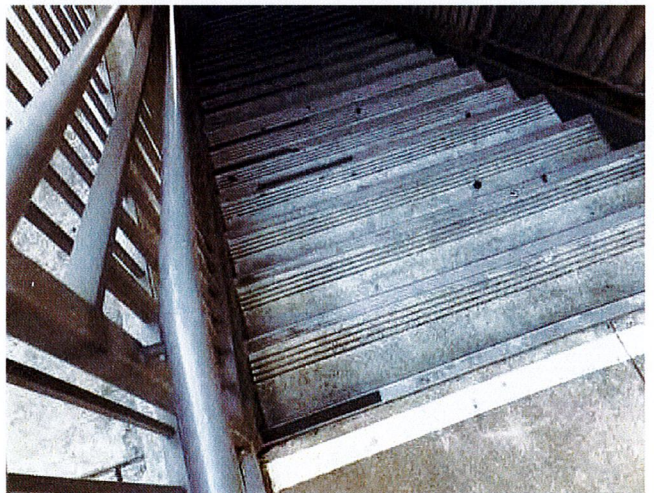
18 - EXTERIOR STAIRS

Generally, the property appears to have been constructed within industry standards in force at the time of construction, to have been well maintained during recent years, and is in good overall condition. The exterior stairs show signs of water intrusion and wood and fastener deterioration in multiple locations. The existing photovoltaic system was reportedly unreliable.

Exterior stairs show deterioration of wooden members and corrosion of metal elements. - AssetCALC ID: 3270061

Uniformat Code: B1081
Recommendation: **Replace in 2021**

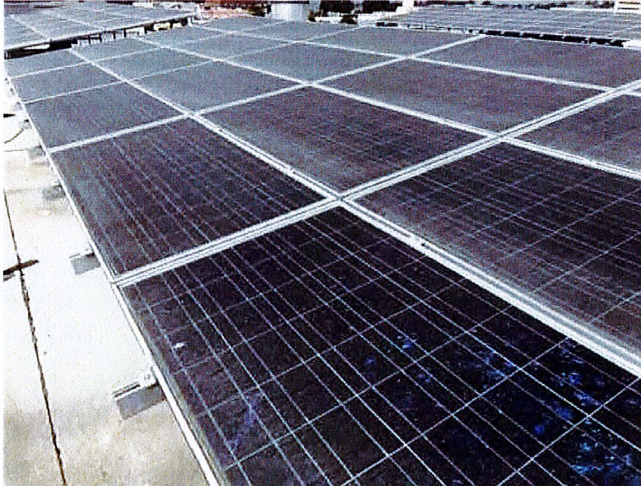
25 - PHOTOVOLTAIC SYSTEM

Solar Power in Poor condition.

Uniformat Code: D5013
Recommendation: **Replace in 2021**
